# DELOS WP 1.1 Inventory on LCS, detailed description

Participant code and who to contact.	UB_EIT
E-mail	ferdy@platonet.it luca.martinelli@mail.ing.unibo.it
This date (today, mm:dd:yyyy) and revision number (AZ).	01/23/2003
Location of LCS.	Amendolara. It is located in Calabria, south of Italy, along the Ionio sea in the Gulf of Taranto
Start date, length and/or end of works. Have there been any later changes? If so, when?	1998
Design life - the minimum length of time the beach management scheme is designed to last.	DK
Which tools and regulations are used for the design formulae (mathematical models, model tests, engineering experience, standards, recommendations).	Engineering experience
Who fund the work (e.g. Public Administration or private company)?	Ministry of Public Works
Costs.	1.600.000 euro

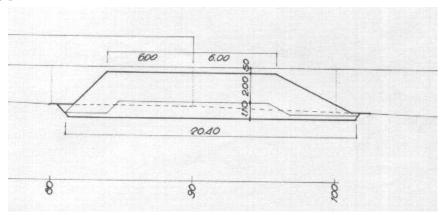
measures in meters

ARMOUR LAYER CHARACTERISTICS			
Parameter	Description	Fill in box	unit
	Material (e.g. quartzite, concrete)	Calcareousl stones	
	Shape of blocks (e.g. quarry rock, sea stones, cubes)	Quarry rock	
$\rho_{\rm r}$	Mass density of material	2600	kg/m <sup>3</sup>
$D_{n50}$	Nominal diameter	1.36	meters
Gr	Grading of the material $(D_{85}/D_{15})$	1.10	
	Geotextile between layers?	☐Yes ⊠ No
