DELOS WP 1.1 Inventory on LCS, detailed description

Participant code and who to contact.	UPC
E-mail	i.caceres@upc.es
This date (today, mm:dd:yyyy) and revision number (AZ).	01:08:2003
Location of LCS.	Altafulla (Tarragona) Spain
Start date, length and/or end of works. Have there been any later changes? If so, when?	1991, construction and first regeneration 1993, second regeneration
Design life - the minimum length of time the beach management scheme is designed to last.	Unknown
Which tools and regulations are used for the design formulae (mathematical models, model tests, engineering experience, standards, recommendations).	Unknown
Who fund the work (e.g. Public Administration or private company)?	Public Administration
Costs.	Construction and first regeneration 1.002.934 € Second regeneration 1.681.649 €

Altafulla Beach

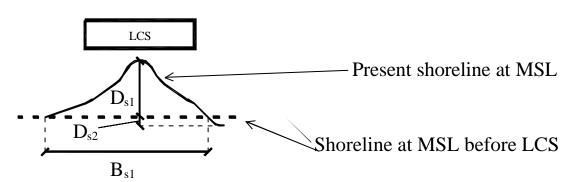
H2 Salient formation

Description of beach evolution after LCS was built up to now. After the two interventions previous mentioned (1991 and 1993) the beach is still losing sand and new regenerations will be required in the future to maintain the beach. The sand lose is bigger in the North of the beach, upstream, and a salient is growing in front of the structure. The total amount of sand in the beach is negative ($D_{s2} > D_{s1}$).

Parameter	Description	Fill in box	unit
D _{s1}	Max distance between new and old shoreline, seaward	30	meters
D _{s2}	Max distance between new and old shoreline, landward	30	meters
B _{s1}	Width of salient at old MSL	175	meters

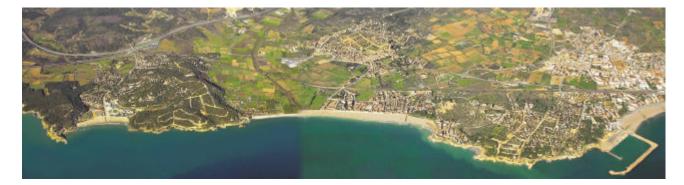
The Structure is placed in a longshore beach of 2 km that is bordered by two big mountains ending in the sea. See picture annexed.
