DELOS – EVK3-CT2000-0041
Deliverable No 5 for WP1.1
LCS in DK
Based on the brief questionnaire

This document summarizes the information collected for DELOS WP1.1 “Inventory of engineering properties of LCS”.

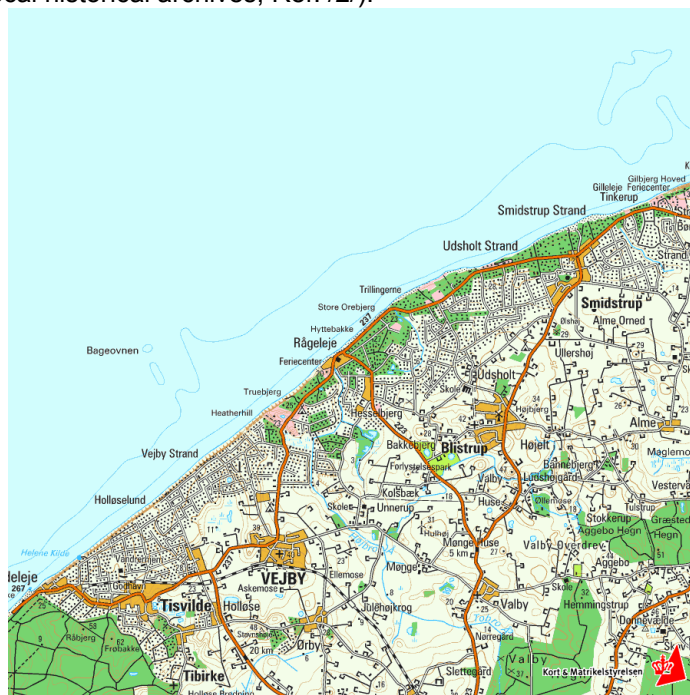
UTM-32 (easting, northing)=(6221746, 696617). The LCS is situated facing Rågeleje harbour (Municipality of Helsingør). Rågeleje is situated on the North coast of Sealand, Denmark – see map below (covering 12.5 km *12.5 km). Information presented below is based primarily on a report made for the local districts (among others Municipality of Helsingør) by DHI in 1984 and on the outline of the area shown in the lower figure (both Ref. /1/). Also a sociological description of the impact of the breakwater on the developments in the local community is available (from local historical archives, Ref. /2/).

The beach profile is flat till about 150 meters from the coast where it becomes moderate (1:30). From approximately the 7 meter depth contour the slope becomes flat again (1:100). The depth 500 meters from the coast is app. 8 meters. See also map above.

The impact of the breakwater can be detected 700 meters east where a resistant hard point (Trillingerne, see map in upper figure) is located and protecting the coast from further erosion. The fact that the breakwater is very old allows its long-term influence on the coast to be studied and may for this reason be of interest for DELOS.

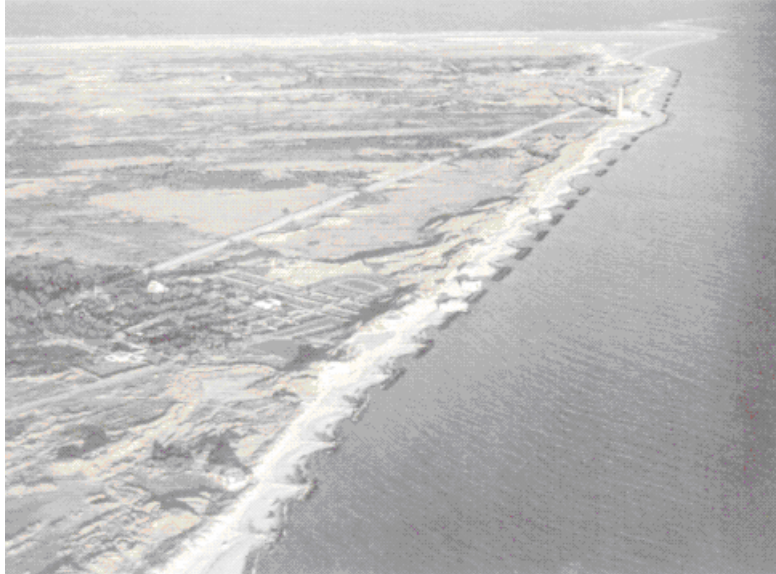
An aerial picture of the system of breakwaters found around Skagen harbour is shown below with the Skaw spit in the horizon.

Between the Grå Fyr lighthouse and the spit, 8 breakwaters have been constructed with gaps between them ranging from 20 to 30 meter (60 meters between number 5 and 6, though). They are 35 to 45 meters long and 10 meters wide. On the stretch from Grå Fyr to Skagen harbour 11 breakwaters were constructed, followed by 7 T-shaped breakwaters. The gaps between the breakwaters are 25 meters (except between number 3 and 4 and 5 and 6 with spacing of app. 80 meters). These are 42 meters long and 10 meters wide. On the southern side of Skagen harbour, south of Klitgården – see the map - 7 T-shaped breakwaters have been constructed. From here the T-shaped structures are followed by 5 breakwaters. The distance between these individual breakwaters (the gap) is 25-30 meters. On average they are app. 30-35 meters long and 5-7 meters wide.

They all have circular round head and aligned parallel to the coast. The system of breakwaters found along the coastline is located sufficiently close to the beach so that tombolo formations are generated. They are without exception connected to the coast, which properly is due to the nourishment. The water depth on the offshore facing side is approximately 1 meter.

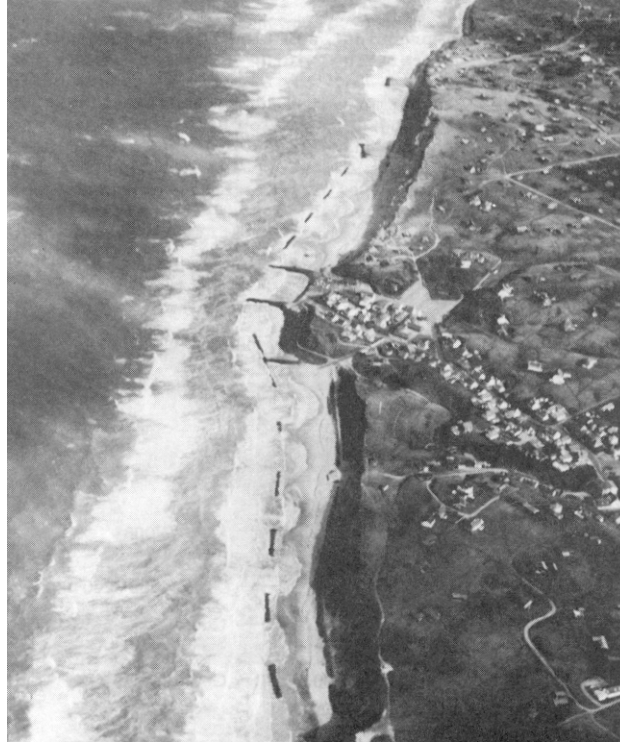
An aerial photo of the system of breakwaters at Lønstrup is shown below. The system is 1100 m long.

Each breakwater is built on approximately 1 meters water depth. They are 45 meters long and separated by 45 meters as well.

All breakwaters have circular round heads and are aligned parallel to the coast. The system of breakwaters found along the coastline is located sufficiently close to the beach so that tombolo formations are generated (see aerial photo).

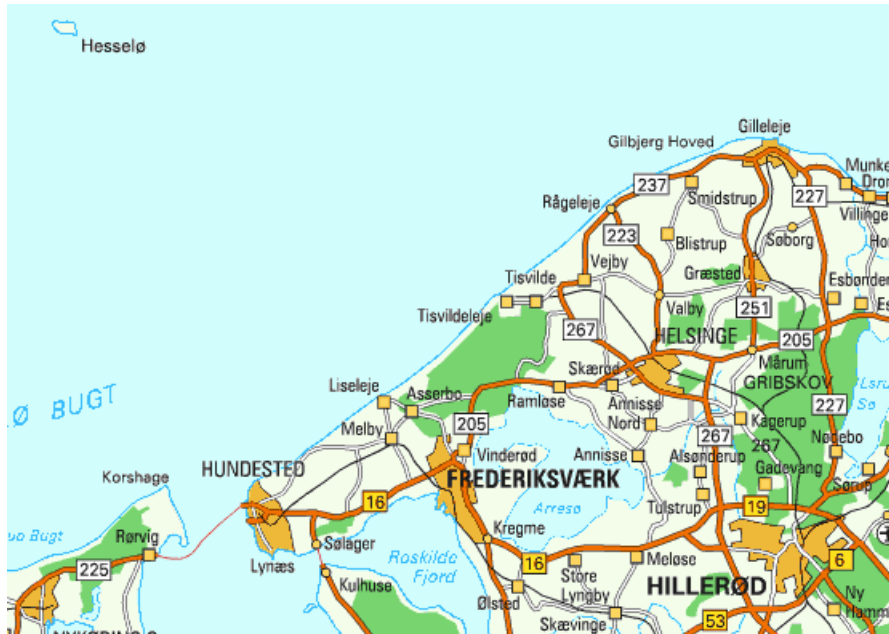
UTM-32 – (easting, northing)=(684549, 6211899). A system of LCS's is situated near Liseleje on the North coast of Zealand, Denmark – see map below. The system contains new as well as old breakwaters.

On the entire Hundested-Gilleleje stretch (see map), the coast is dominated by waves from west and northwest. These waves cause a netto-transport of material towards east at app. 10.000-30.000 m³/yr.
