DELOS – EVK3-CT2000-0041
Deliverable No 5 for WP1.1
LCS in GR
Based on the brief questionnaire

This document summarizes the information collected for DELOS WP1.1 “Inventory of engineering properties of LCS”.

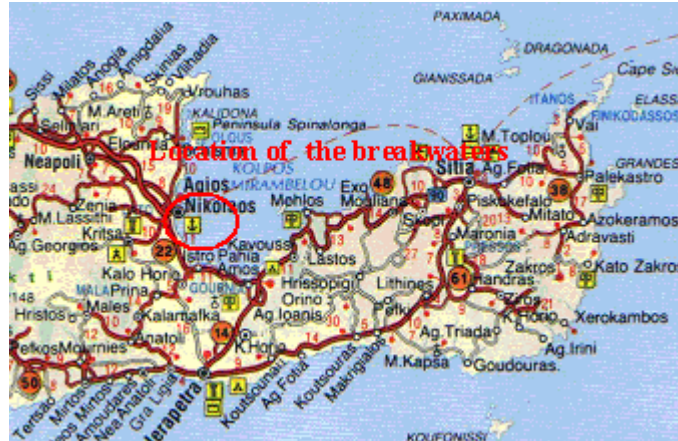
System of 3 successive detached breakwaters parallel to the shoreline at St. Nikolaos, Lasithi, Crete. St. Nikolaos (red circle) is situated in Eastern Crete. The map below is not scaled.

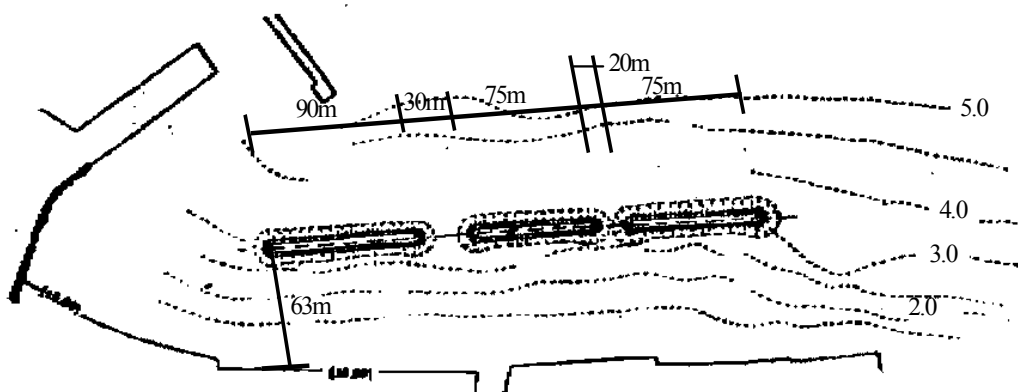
Typical cross section (dimensioned sketch)

The cross section has a trapezoidal shape. The breakwaters are probably armoured with natural stones. The crest of the breakwaters is 1.2 m above still water level. No further details available.

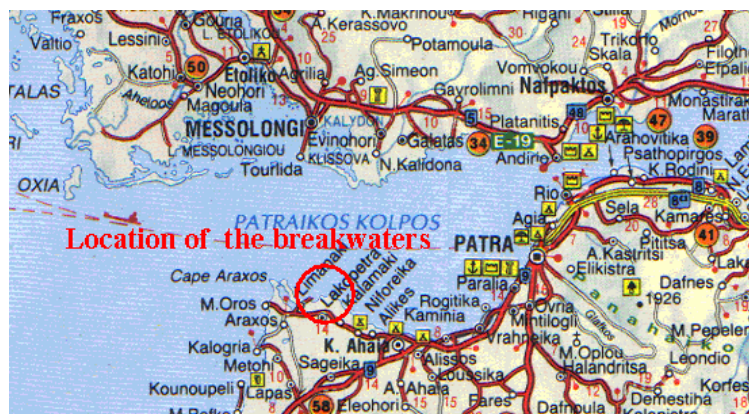
Three successive detached breakwaters parallel to the shoreline at Lakopetra, Ahaia. Lakopetra (red circle) is located on the North West coast of Peloponnisos 10 km eastwards of the entrance of Patraikos Gulf. The map below is not scaled.

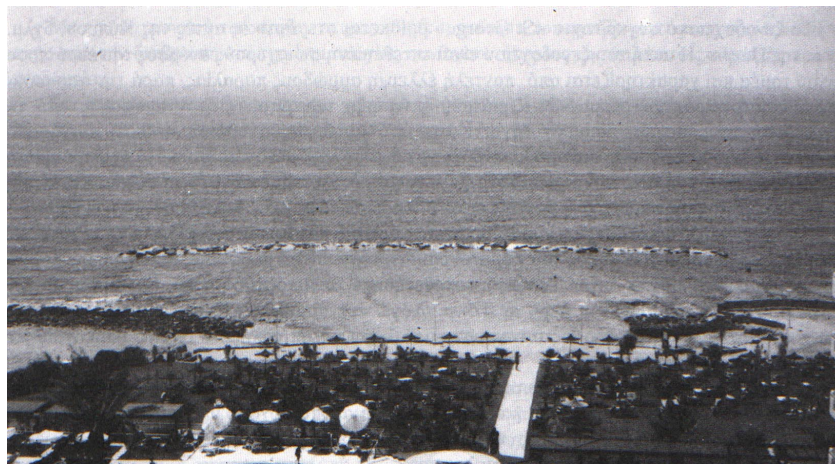
System Layout (dimensioned sketch)

The breakwater is curved shaped. System layout characteristic dimensions are :

Breakwater length : 110 m

Offshore distance : 70 m

Crest width at the body : 5.0 m

Crest width at the round head : 7.5 m

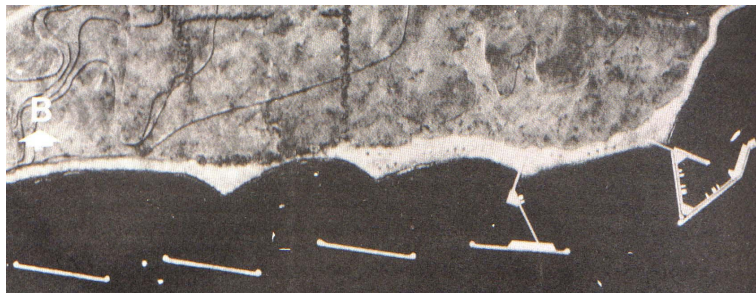
System Layout

System layout characteristic dimensions are :

Angle between breakwaters and shoreline : 13°

Breakwaters length : 140 m

Gap between the breakwaters : 25 -30 m

Offshore distance : 140 m

Crest width : 3.7 m
