DELOS WP 1.1 Inventory on LCS, detailed description

Participant code and who to contact.	UB_EIT EMANUELA CLEMENTI
E-mail	emanuela.clementi@mail.ing.unibo.it
This date (today, mm:dd:yyyy) and revision number (A..Z).	02:15:2003
Location of LCS.	CESENATICO (North of the port)
Start date, length and/or end of works. Have there been any later changes? If so, when?	Start date: November 2001 Not yet completely finished
Design life - the minimum length of time the beach management scheme is designed to last.	25 years
Which tools and regulations are used for the design formulae (mathematical models, model tests, engineering experience, standards, recommendations).	Mathematical models, engineering experience, standards
Who fund the work (e.g. Public Administration or private company)?	Public Administration
Costs.	8.200.000.000 £ 4.250.000 EURO

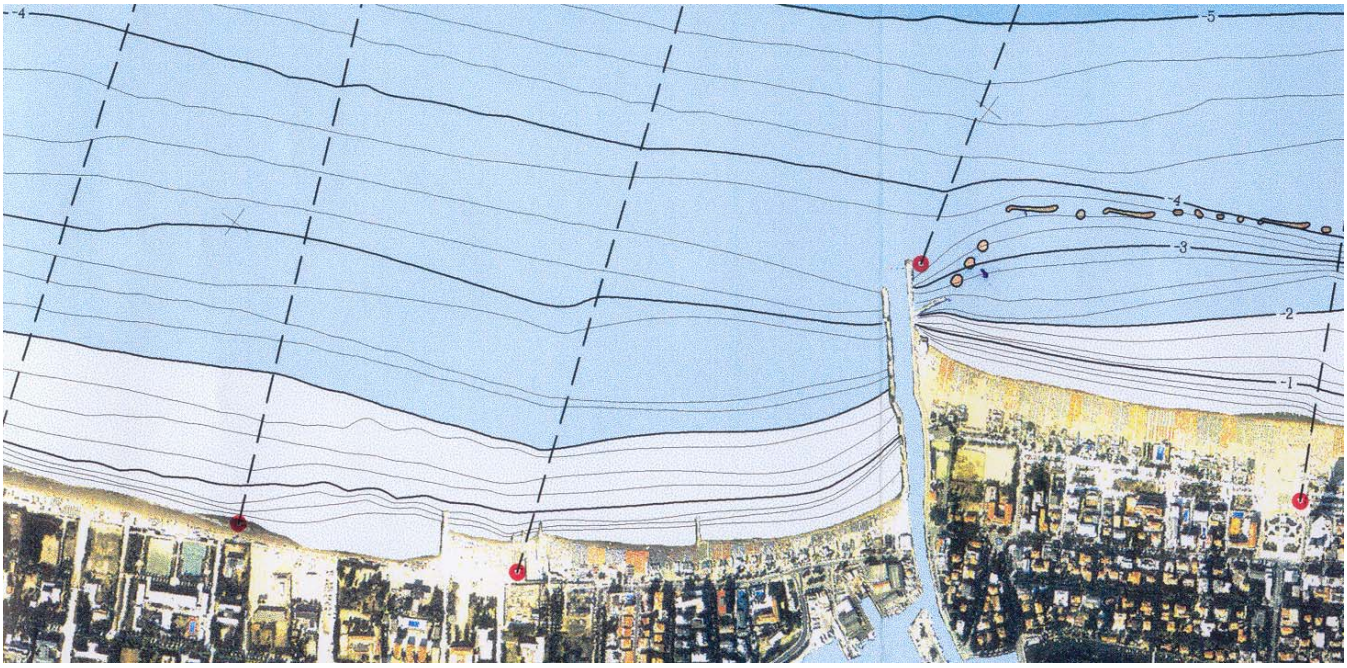
Scale 1:10000

Bathymetry when LCS were built.

From bathymetries between 1984 and 1993, considerable subsidence is visible even off-shore at -6/-8 m depth. In this period the shoreline, next to the North side of Cesenatico harbour, has receded 15 m.

Comparing 1995 and 1996 bathymetries, is visible an accretion zone near the North wharf of Cesenatico harbour, a considerable erosion in the central groin and in the final zone (North side) of flexible structures.

In the same period the volume variation of sediments in the area between sandy sack barriers is about -18000 m^3 .
