Participant code and who to contact.	AUTH GR J. Avgeris
E-mail	iavgeris@civil.auth.gr
This date (today, mm:dd:yyyy) and revision number (A..Z).	17/09/01 Rev A
Location of LCS.	Patras Gulf, west side Hotel "Akti Lakkopetra"
Start date, length and/or end of works. Have there been any later changes? If so, when?	Start in 1991. Construction period, 4 months approx. No further change.
Design life - the minimum length of time the beach management scheme is designed to last.	50 years
Which tools and regulations are used for the design formulae (mathematical models, model tests, engineering experience, standards, recommendations).	Mathematical models, engineering experience and international literature recommendations.
Who fund the work (e.g. Public Administration or private company)?	Private company
Costs.	50.000.000 drs (1991)

AUTH_GR_003 – Lakopetra, Ahaia

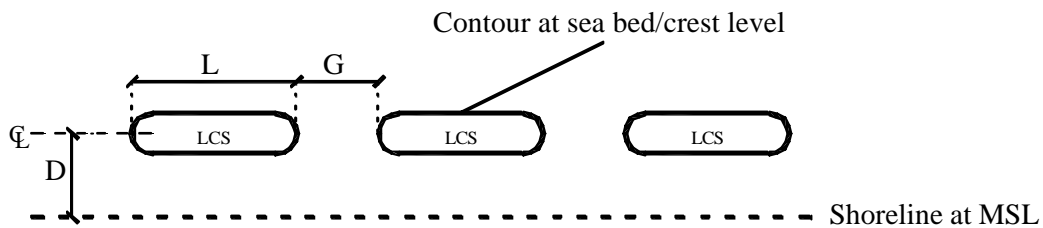
B1 System layout (aerial view)

The typical layout is given at Sea Bed (index SB) and at Crest Level (index CL).

Parameter	Description	Fill in box	unit
D	Distance from shoreline	125	meters
L_{SB}	Length of LCS at sea bed	85	meters
L_{CL}	Length of LCS at crest level	67	meters
G_{SB}	Gap between LCS at sea bed	25	meters
G_{CL}	Gap between LCS at crest level	43	meters
n	Number of LCS in system	3

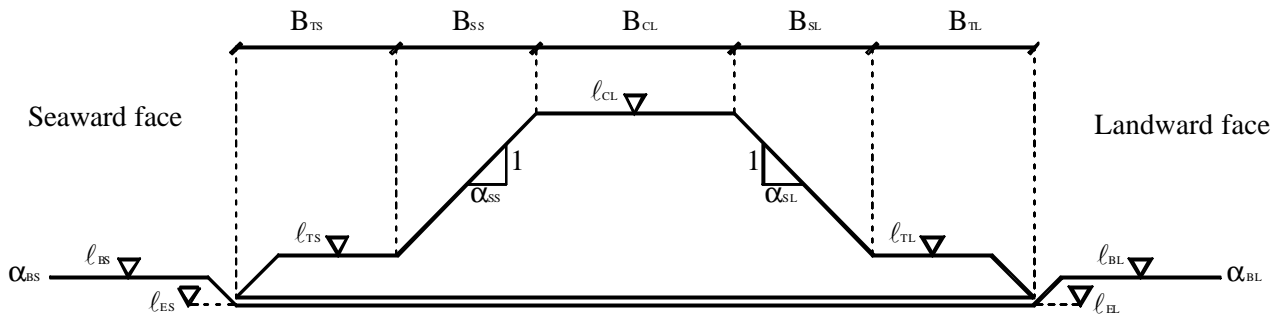
B3 Trunk cross section/contour geometry – outer profile

Parameter	Description	Fill in box	unit
α_{BS}	Steepness of sea bed, seaward	2,5	%
α_{BL}	Steepness of sea bed, landward	2,5	%
α_{SS}	Steepness of slope, seaward	2:1	
α_{SL}	Steepness of slope, landward	3:2	
l_{BS}	Level of sea bed at seaward toe	- 3,3	meters
l_{ES}	Level of excavation, seaward	-	meters
l_{TS}	Level of toe, seaward	-	meters
l_{CL}	Level of crest	+ 0,7	meters
l_{BS}	Level of sea bed at landward toe	- 3,0	meters
l_{ES}	Level of excavation, landward	-	meters
l_{TS}	Level of toe, landward	-	meters
B_{TS}	Width of toe, seaward	-	meters
B_{SS}	Width of slope, seaward	7,0	meters
B_{CL}	Width of crest	3,0	meters
B_{SL}	Width of slope, landward	5,0	meters
B_{TL}	Width of toe, landward	-	meters

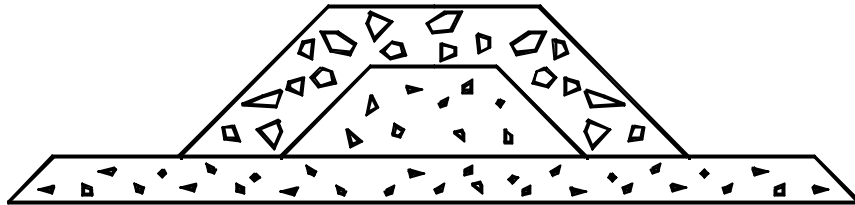
B5 Description of layers

ARMOUR LAYER CHARACTERISTICS (2 x D ₅₀)			
Parameter	Description	Fill in box	unit
	Material (e.g. quartzite, concrete)	Quarry rock	
	Shape of blocks (e.g. quarry rock, sea stones, cubes)	Quarry rock	
ρ_r	Mass density of material	2650	kg/m ³
D _{n50}	Nominal diameter	1,0	meter
Gr	Grading of the material (D ₈₅ /D ₁₅)	1.5 – 2.5 Tons	
	Geotextile between layers?	<input type="checkbox"/> Yes <input checked="" type="checkbox"/> No

2nd layer formed by quarry rock 150 – 200 kg (Weight of armoring/10)

Core layer formed by filling 0.1 to 100 kg. For more details see attached drawings.
